# **Santa Margarita River Home<sub>2</sub>Ocean A Citizen's Water Quality Monitoring Program**

## **Data Report**

### **Data Summary and Interpretation**

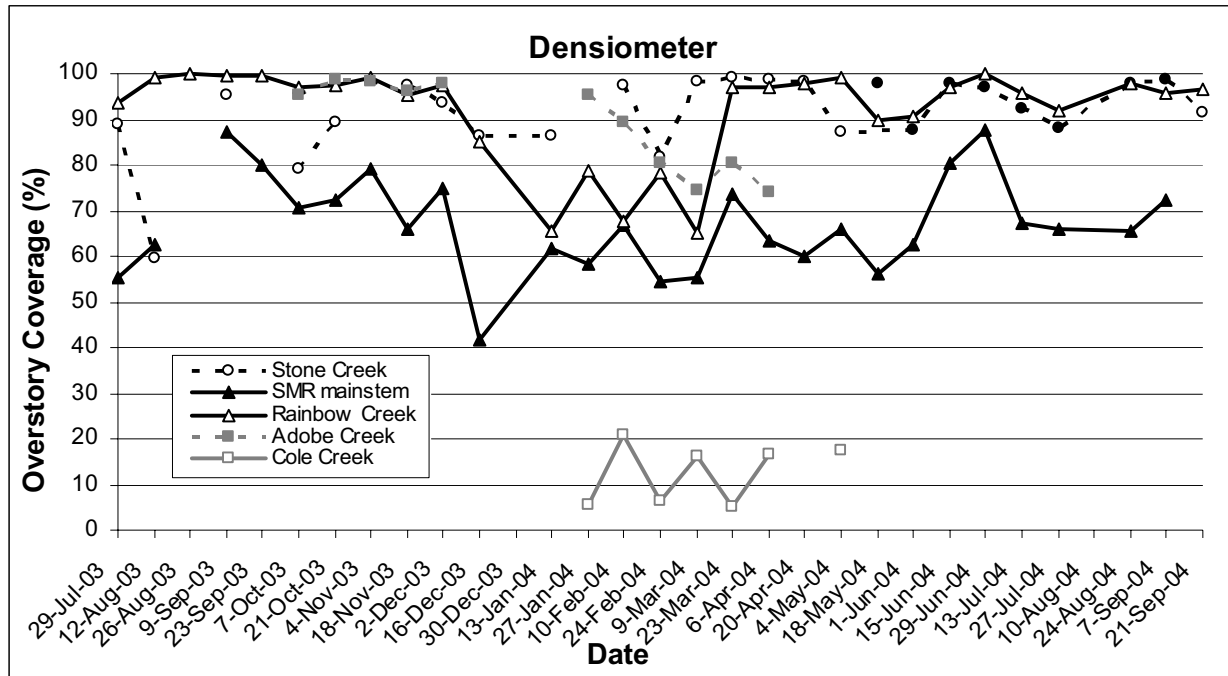
Figure 1. The physical habitat condition of percent overstory coverage, or canopy density, was monitored at all five of the sampling sites during the sampling period of July 29, 2003 through September 30, 2004. Stone Creek was sampled at two sites: sampling site one (open circles) and sampling site two (closed circles). The x-axis scale represents each date the physical habitat conditions were recorded.

Stone Creek maintained a fairly high and stable canopy density. This was thought to be due to the fact that Stone Creek is lined with coast live oak trees (*Quercus agrifolia* Nee), which is predominantly due to perennial low flow water conditions. Very rare flooding regimes with low flow conditions allow for the growth of the thick oak canopy. The combination of the oaks' thick foliage and the fact that they are an evergreen tree resulted in consistently high percentages of overstory coverage throughout the year.

Rainbow Creek is lined with sycamore trees (*Platanus occidentalis*), which are deciduous (they lose their leaves during the fall and winter months and grow new leaves each spring). A low flooding regime with stable, unvarying water conditions leads to high canopies that change seasonally. During the spring and summer, the canopy maintained a high percentage of overstory density (usually at or near 100% coverage), as the sycamores were densely populated and had large, healthy leaves. However, when the sycamores lost their leaves in the fall and winter, the percent density dropped in response. During the March 2004 sampling

Santa Margarita River is lined with sycamores and coast live oaks, as well as other tree species. However, it is not as densely distributed, which resulted in the percent overstory coverage to be lower than the densely populated Rainbow and Stone Creeks. High flooding regimes combined with high flow conditions result in long-term fluctuations in canopy density due to vegetative breakdown, regeneration, and seasonal changes. When the sycamores lost their leaves, a decrease in the percent overstory coverage was observed for this site, as well. The percent overstory coverage began to regain its previous summer density as the leaves on the sycamores grew back.

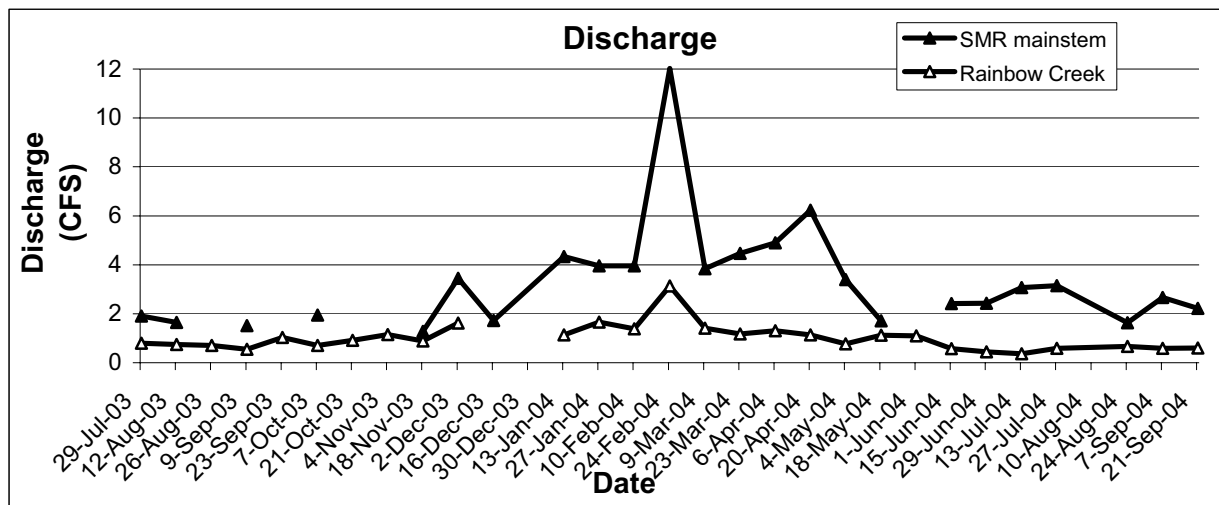
Figure 3. The physical habitat condition of discharge (streamflow) in Rainbow Creek and the Santa Margarita River (SMR) mainstem was monitored at Rainbow Creek and the Santa Margarita River mainstem sampling sites during the sampling period of July 29, 2003 through September 30, 2004. The x-axis dates correspond with the Home<sub>2</sub>Ocean Program's water quality sampling dates. The y-axis is the streamflow in cubic feet per second (CFS).

The hydrograph of Figure 3 discloses several facts. The primary fact is that the Santa Margarita River (SMR) always had a much greater discharge rate (cubic feet per second) than Rainbow Creek. This is interesting to note as the Rainbow Creek sampling site was approximately 1 to 1.5 feet wider than the SMR sampling site, while it is approximately 1 to 2 feet shallower than the SMR sampling site. This means that more water was flowing through a narrower, deeper channel at the SMR sampling site than at the Rainbow Creek sampling site. Second, streamflow, at both sites, increased in response to increasing rainfall amounts. The drainage area of the Santa Margarita River watershed is much larger than the sub-watershed of Rainbow Creek, and so its streamflow increase was dramatically larger as it peaked at nearly 12 cubic feet per second. The streamflow at Stone Creek was never measured due to the fact that there was not enough velocity and water volume to perform a streamflow measurement. This fact is important to note as Stone Creek is approximately 1 to 2 feet wide and about 1 to 6 inches deep (approximately 1 sq ft) in comparison to the 13 foot wide and 2 foot deep (26 sq ft) SMR. Rainbow Creek is approximately 14 sq ft (14 foot wide and 1 foot deep). Stone Creek is much smaller and has less velocity and water volume than the other two sampling sites, which will affect water quality parameters, such as dissolved oxygen and bacterial counts.

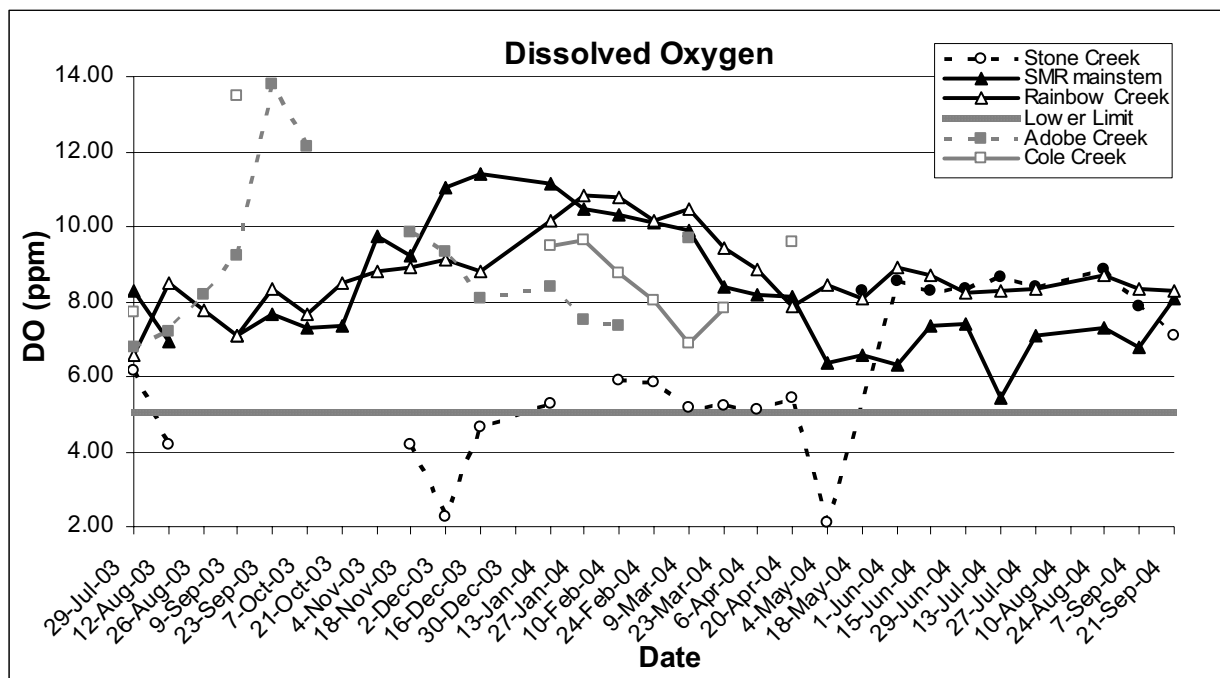
Figure 6. The water quality parameter of dissolved oxygen (in parts per million) was monitored at all five of the sampling sites during the sampling period of July 29, 2003 through September 30, 2004. Stone Creek was sampled at two sites: sampling site one (open circles) and sampling site two (closed circles). The x-axis dates correspond with the Home<sub>2</sub>Ocean Program's water quality sampling dates.

Over the course of the sampling period, the dissolved oxygen (DO) levels increased as the water temperatures decreased. This was an expected relationship between the two parameters as gases are more soluble in colder waters. Cole Creek had a high DO value for the sampling date of September 9, 2003, while Adobe Creek had high DO levels for the sampling dates of September 23 and October 7, 2003. The reasons for the high DO levels, at these two sampling sites, is that there were algae blooms in the water at the sampling sites. As the sites were sampled in the middle of the day, the plants were photosynthesizing and thus producing oxygen rather than using it. Stone Creek had noticeably lower DO levels than the other four sites. There are two possible reasons for this trend. First, there is very little algae or aquatic plant cover within Stone Creek, possibly a result of the consistent shade from the overstory canopy. Almost 100% of the plants growth is on the banks of the creek. This lack of vegetation in the stream would result in very little oxygen input into the water from biotic sources. Second, the water only trickles through the riffles at Stone Creek. There is not a lot of high velocity turnover of the water or turbulence, which would increase the DO levels in the water. These reasons were apparent during the May 4, 2004 sampling when samples were taken at one of the few standing pools of water that remained in Stone Creek. Also, for this sampling date, the decomposition of organic material (i.e. leaves, other plant material) would also have caused the DO in the water to plummet. During the next sampling date of May 18, 2004, the sampling location was moved to the second sampling site for Stone Creek.

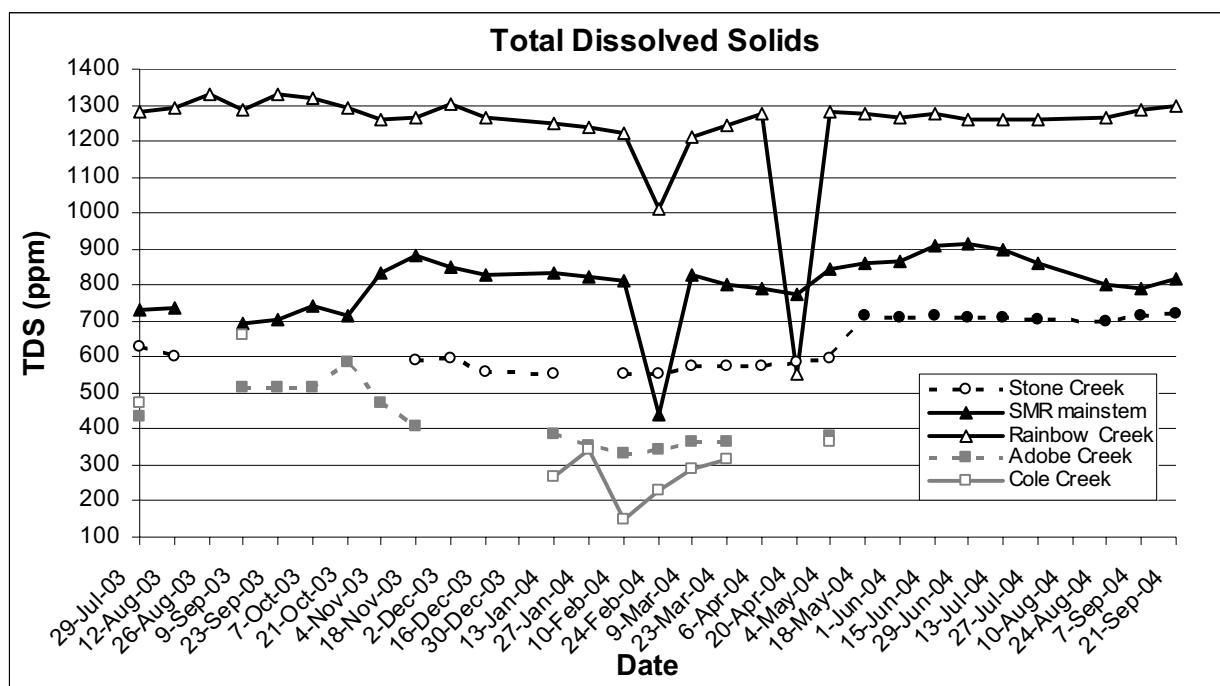
Figure 8. The water quality parameter of total dissolved solids (in parts per million) was monitored at all five of the sampling sites during the sampling period of July 29, 2003 through September 30, 2004. Stone Creek was sampled at two sites: sampling site one (open circles) and sampling site two (closed circles). The x-axis dates correspond with the Home<sub>2</sub>Ocean Program's water quality sampling dates.

The Basin Plan Water Quality Objectives state that the TDS levels in inland surface waters in the San Diego Region should range between 300 and 2100 ppm. Four of the five sites fell within this TDS value range. Cole Creek was below 300 ppm on four of the nine occasions it was sampled. A hydrologist, for the Santa Rosa Plateau Ecological Reserve equated the reserve to a sponge (decomposed granite with easy infiltration) which results in the water in the creeks (Adobe and Cole Creeks) coming from the ground, as opposed to surface runoff. The source of the water in the creeks is flowing and surfacing ground water, unless there is a very large storm event in which there will be surface runoff. This would be especially true around Cole Creek where the soil is mostly decomposed granite. Around Adobe Creek, there are more loamy soils, which might not filter dissolved solids as well as decomposed granite. Stone Creek and Adobe Creek had low TDS levels, which could be attributed to the fact that very little of the water in both creeks is from residential, agricultural, or commercial properties. Santa Margarita has a site specific Basin Plan Objective, which states that TDS levels must stay below 750 ppm. The Santa Margarita River TDS measured above 750 ppm

approximately 75% of the sampling dates. These high TDS levels may be attributed to agricultural runoff and the lack of dilution in the water body from rain water (as most of the high TDS levels were measured during the dry season). The higher TDS levels in Rainbow Creek can probably be attributed to the high levels of agricultural runoff in the water body. The drop in TDS at Rainbow Creek and SMR, on February 24, 2004, is thought to have been caused by the large rainfall events of that time period. The waters in the creek and river were diluted by rainwater that the TDS levels dropped significantly for a short time.

The TDS levels were much greater at the second sampling site of Stone Creek than the first sampling site. This is interesting to note as it is fed directly from a spring at the second site, which could have caused the increase in TDS.

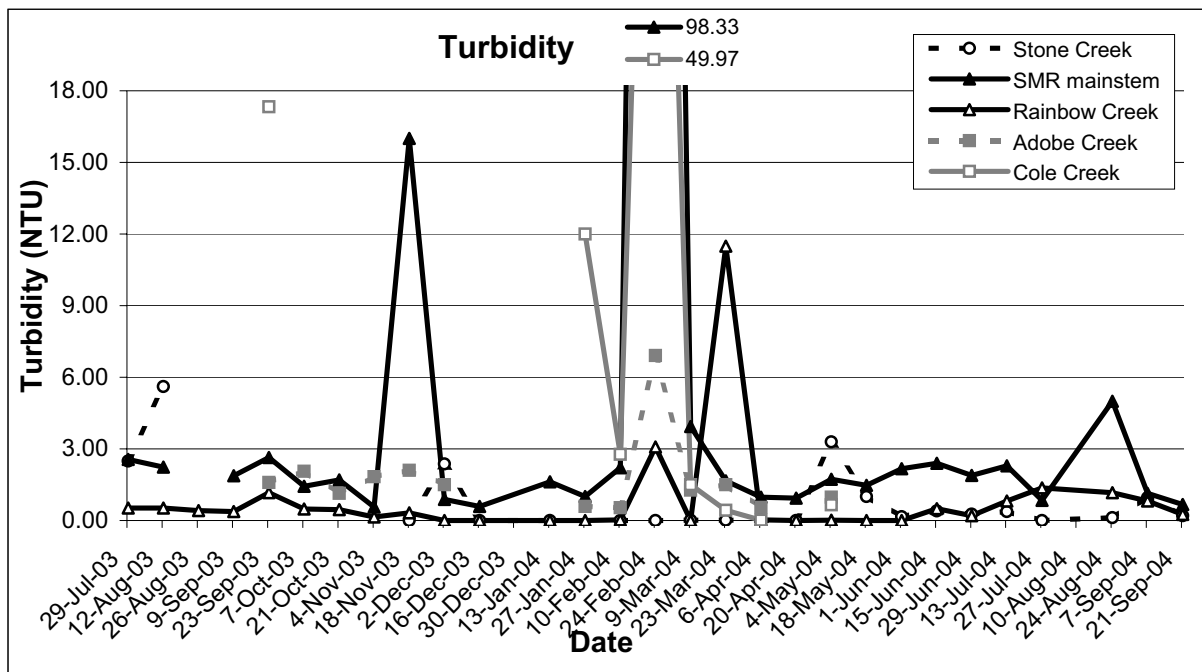
Figure 9. The water quality parameter of turbidity (in NTUs) was monitored at all five of the sampling sites during the sampling period of July 29, 2003 through September 30, 2004. Stone Creek was sampled at two sites: sampling site one (open circles) and sampling site two (closed circles). The x-axis dates correspond with the Home<sub>2</sub>Ocean Program's water quality sampling dates.

The Water Quality Objectives in the San Diego Basin Plan state that inland surface waters shall not exceed a maximum level of 20 NTUs for turbidity. This objective was violated once at the SMR sampling site and once at the Cole Creek sampling site. All of the spikes in turbidity (for all of the sites) occurring from November 4, 2003 to March 9, 2004 can be attributed to rainfall events. The SMR sampling site had the highest sediment levels, which turned the water murky and opaque suggesting impacts from sedimentation. The turbidity level on February 24, 2004 actually peaked at 98.33 NTUs. These spikes could have been caused by sediment from erosion that has been exacerbated by landscaping, construction, and agriculture. The spike on Stone Creek, on August 12, 2003, is thought to have been a result of natural causes, although it is unknown what those causes were. All of the water in Stone Creek, at that time, was in standing pools.

The spike seen March 23, 2004, on Rainbow Creek, was caused by sediment pollution, which was not related to a rainfall event. A small tributary on Rainbow Creek, a short distance upstream of where sampling took place, had tremendously high sediment content and was causing all of the water in Rainbow Creek, downstream of the tributary, to become murky and opaque. It was thought that either a construction job was occurring upstream in the tributary or that an agricultural operation was doing some landscaping. This was the first time that the water in Rainbow Creek was murky, as it had always been crystal clear and the bottom of the creek bed was always easily seen. The September 23, 2003 spike seen on the Cole Creek sampling site is from an unknown origin, as is the August 24, 2004 spike seen on the SMR sampling site. Algae was noted in this water body during that time period and it is unknown if the algae growth was a cause of the spike in turbidity or a consequence of the high turbidity.

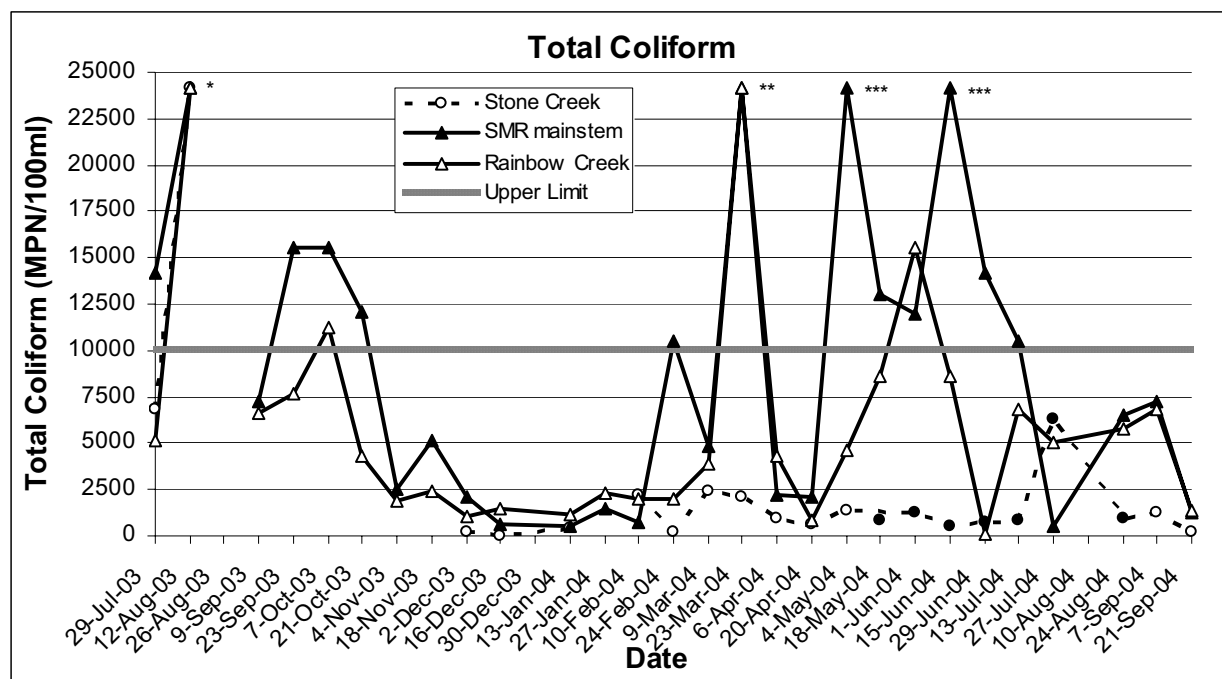
\* Total coliform levels, at all three of the sampling sites, met or exceeded the upper limit (24,200 MPN/100 ml) of the total coliform test performed by the state certified laboratory.

\*\* Total coliform levels, at the Rainbow Creek and the Santa Margarita River mainstem sampling sites, met or exceeded the upper limit (24,200 MPN/100 ml) of the total coliform test performed by the state certified laboratory.

According to the County of San Diego Department of Environmental Health, the upper limit of the acceptable range for total coliform is 10,000 MPN/100 ml. This standard for recreational waters indicates that SMR mainstem and Rainbow Creek surpassed the standards and would be considered contaminated for several sampling dates. It is unknown what caused the spike on August 12, 2003. It could possibly be attributed to laboratory error and probably does not reflect the true value of total coliform in the water bodies. The spike observed on March 23, 2004 can be correlated with the high turbidity levels in Rainbow Creek and the Santa Margarita River. This was after a rainfall event and can reflect mammal waste that was washed into the water bodies. A trend that can be seen is that as the rainy season started in

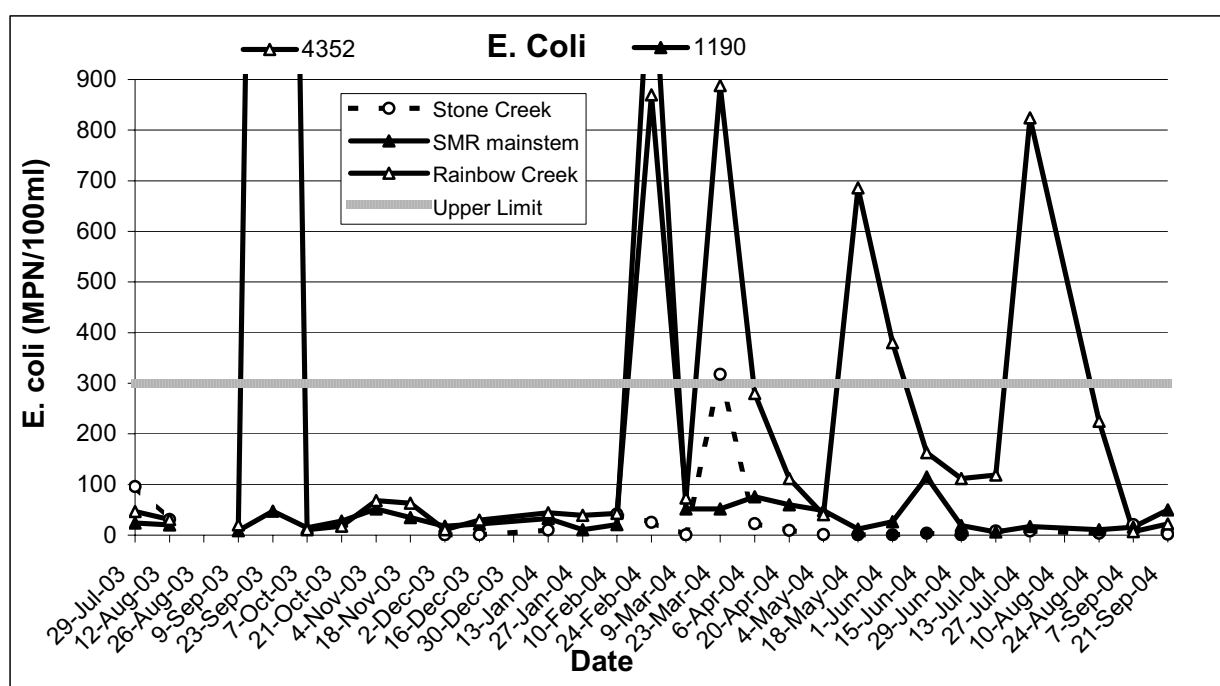
\* *E. coli* levels at the Rainbow Creek sampling site.

\*\* *E. coli* levels at the Santa Margarita River mainstem sampling site

The spikes seen on February 24 could be attributed to first flush measurements, as a rather large rainfall event occurred only 2 days prior to sampling. However, Rainbow Creek spikes again, on March 23 and July 27, 2004, which are not near a rainfall event. The cause of these spikes is not understood, nor is the spike, March 23, 2004, for Stone Creek. It could be that the few residences in the Stone Creek watershed had overflowing of their septic tanks, in March, due to the rainy season. The February 24, 2004 spikes, for Rainbow Creek and the Santa Margarita River, could be attributed to storm water runoff carrying animal waste and septic system failures. The September 23, 2003 spike on Rainbow Creek could be attributed to human error or a septic system malfunction from farther upstream.

The standard for recreational waters indicates that Rainbow Creek regularly surpassed the standards and would be considered contaminated at those times. This contamination probably cannot be attributed to failed septic systems as the septic system failures or sewage spills usually result in a 1:1 ratio of *E. coli* and total coliform. The spikes could be attributed to domestic or wild waste. Another possibility is that human waste, not coming from a septic system, was responsible for the high levels. The Rainbow Creek and SMR spikes seen on February 24 could be attributed to first flush measurements, as a rather large rainfall event occurred only 2 days prior to sampling.
